**Annual Inspection carried out at
Sutton Weaver Play Area, Sutton Weaver
on 10th June 2024
on behalf of Sutton Weaver PC**

**Alan Dymond, RPII Annual Inspector
(No. 1056A)**

Name of Play Area: Sutton Weaver

Date: 10/06/2024

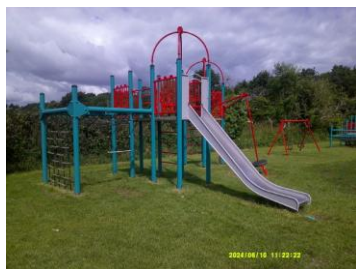
(1) Junior Multi-Play Unit

This item fails to meet the requirements of BSEN 1176 in the following respect:

The climbing net is broken – chains loose – repair – *medium risk*.

Platform timber has been kicked out of the fixing point and is loose and damaged – replace – *medium risk*.

Decay evident – monitor – *low risk*.

Corrosion evident – treat, rub down and re-paint – *low risk*.

Moss growth evident on item – remove and clean – *low risk*.

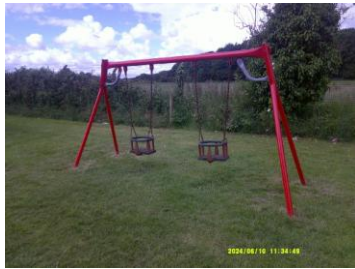
(2) Swings 1.8m High, 1 Bay/2 Seat (Cradle)

The item meets the requirements of BSEN 1176 where this may be tested on site without dismantling or destruction.

The chains are very rusty – replacement advised – low risk.

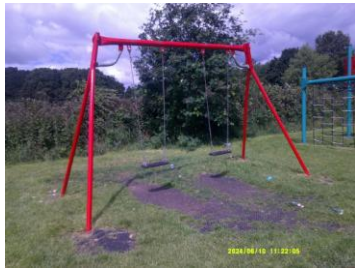
(3) Swings 2.4m High, 1 Bay/2 Seat (Flat)

The item meets the requirements of BSEN 1176 where this may be tested on site without dismantling or destruction.

The item is in good condition and no work is required at this time.

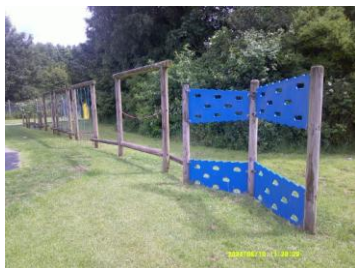
(4) Activity Trail

The item fails to meet the requirements of BSEN 1176 in the following respect:

Finger entrapments evident across the unit – monitor – low risk.

Hand over foot rope - shearing/crushing point – shorten to alleviate.

A number of support posts are badly decayed at and below ground level – replacement of those posts advised – *medium risk*.

Rope wear evident – tape up and monitor.

Crossbeams are “blackened” suggesting potential rot/decay – resistograph test recommended to assess – *medium risk*.

Bolt cap covers missing – protruding bolts evident – replace – *low risk*.

Moss growth evident on timbers – remove and clean – *low risk*.

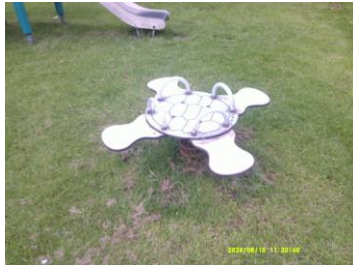
(5) Spring Rocker – Turtle

The item meets the requirements of BSEN 1176 where this may be tested on site without dismantling or destruction.

The item is loose in the ground and can be twisted around on the spring – secure both the base and the seat – *low risk*.

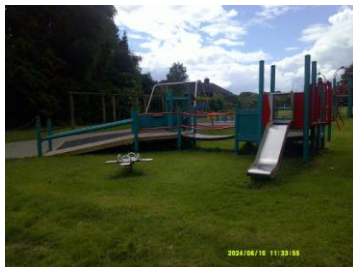
(6) Toddler Multi-Play Unit

The item fails to meet the requirements of BSEN 1176 in the following respect:

Horizontal barriers in place on platforms and bridges – solid or vertical infill's are advised – *low risk*.

Decay evident – replace affected timbers – *low risk*.

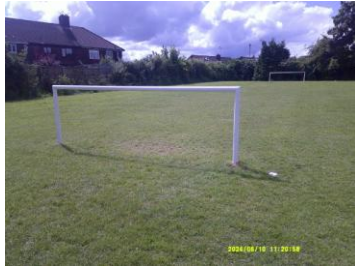
(7) Goal Posts x 2

The items are in good condition and no work is required at this time.

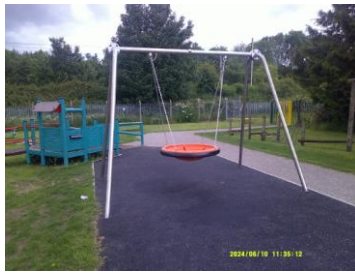
(8) Basket Seat Swing

The item is in good condition and no work is required at this time.
