**Annual Inspection carried out at
Sutton Weaver Play Area, Sutton Weaver
on 10th June 2024
on behalf of Sutton Weaver PC**

**Alan Dymond, RPII Annual Inspector
(No. 1056A)**

Name of Play Area: Sutton Weaver

Date: 10/06/2024

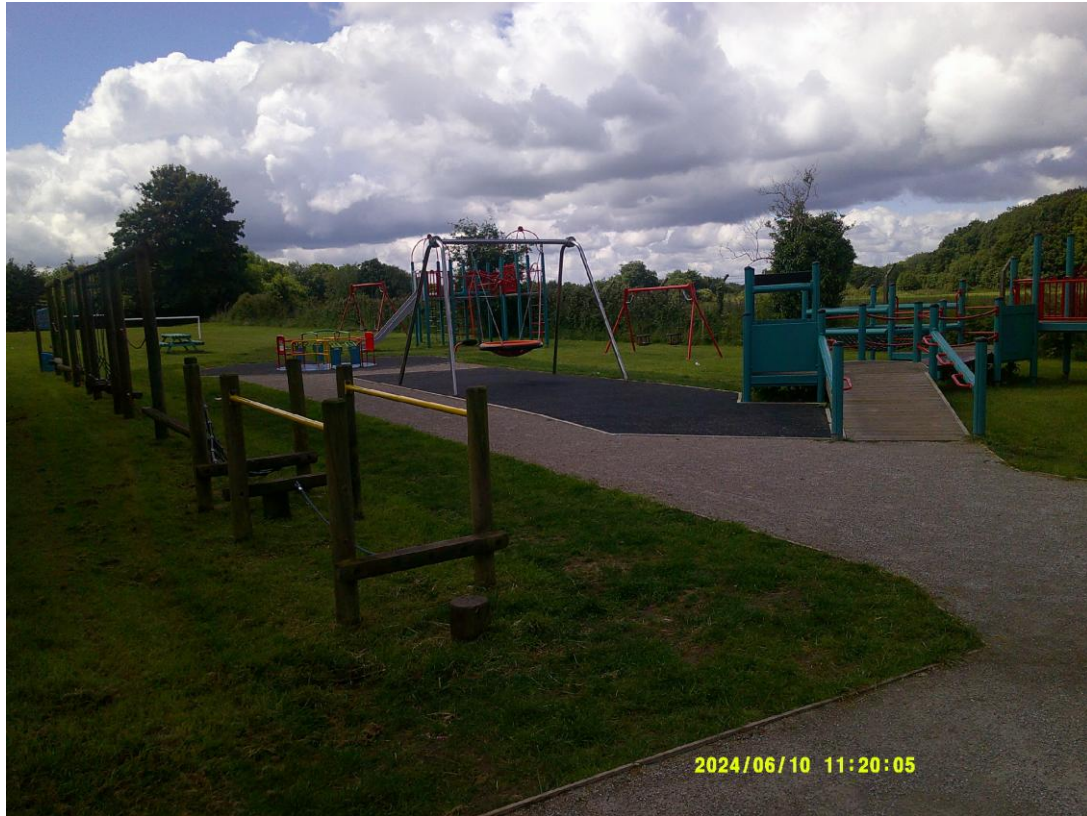
The play area is a local sized facility, sited in an enclosed recreational field. The site has been redeveloped since last year's annual inspection with the installation of new items of equipment and wetpour safer surfacing. The timber fence lining and gate has been removed from around the toddler area, items of equipment have been re-sited and re-painted. A new access gate and stone access pathways have also been installed.
